## **15—503     Formation of deposits on breaker contact points (contact-controlled transistorized ignition system)**

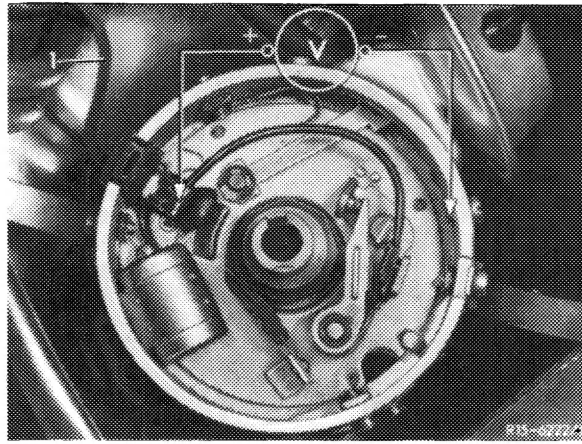
Formation of blue or dark-grey deposits on contact breaker points of transistorized ignition system may lead to misfiring by insulating characteristics during progressive stage. Pertinent complaints have resulted in unjustified exchange of switching unit.

Blue deposits (tungsten oxide) are formed by the arc occurring during the dwell stage and the resulting burning of contact material. This arc is caused above all by the discharge of the suppression capacitor installed in ignition distributor.

A large dwell angle (small breaker point gap) favors the intensity of the arc and thereby the formation of deposits.

Dark-grey deposits are caused by burnt grease, oil or dirt particles, formed between breaker points.

With closed contacts, the voltage drop may amount to 0.5 volt. A higher voltage drop indicates already a beginning formation of deposits.

1 Control line with capacitor

1. Deposits on contact breaker points:
  - a) Exchange contact breaker points (refer to repair instructions).
  - b) Remove control line with capacitor and replace by **shielded control line without capacitor**.
2. Score marks on distributor cam or chafed lubrication felt:

Exchange ignition distributor. On new ignition distributor, mount a shielded control line without capacitor prior to installation.
